## **Friends of Melaleuca, Wildcare Inc. Report to PWS and Wildcare, June 2018**

### ***Working bee, March 2018***

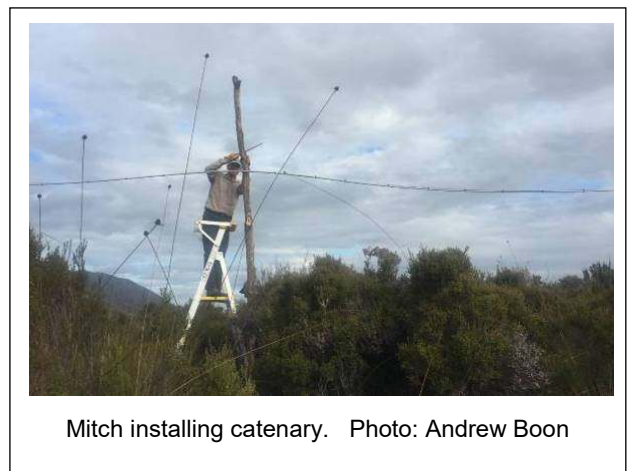
This year Andrew, Rik and Mitch continued with work on the Willsons project. Andrew purchased the requisite electrical materials (including 4m lengths of conduit) and took them to Melaleuca on his yacht. The team replaced the AC wires from Willsons' workshop to the house with compliant

cabling. To do this they set up support poles between the wind generator tower and workshop; suspended a wire rope catenary from the workshop via the poles and tower to the house; threaded existing wires into 20mm conduit, and fastened this up to the catenary. At the house, the cable now runs in conduit along the back wall to a flexible tail that can be plugged into the appliance inlet in the porch. And the earthing has been made compliant by a direct connection from the appliance inlet to an earth stake.

They also improved the Willsons' DC system by fitting a battery isolator and a fuse, and installed a set of six distribution fuses for the house loads.

All work was tested and confirmed functional.

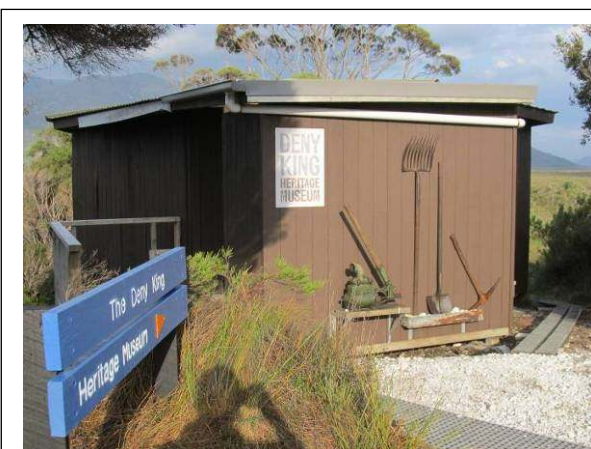
Cladding on the exterior of the building is warping and cracking. During the working bee David and Wendy re-coated it with 'Ironbark' stain and screwed in the most warped planks to tide it over until re-cladding is possible. New signage for the museum was installed as some visitors have been missing it. A printed sign was screwed on the outside wall. David and Wendy repainted and relocated the PWS sign to near the entry. Brackets were fixed to the wall to support ledges for displaying a hand pump and mining hand-tools. Thanks to pilot James (Par Avion) for procuring the brackets for us.

New signage and exterior display, Deny King Heritage Museum. Photo: Geoff Fenton

- Replace exterior cladding with 'shadow-clad'. (PWS)
- Repaint exterior (FoM).
- Replace temporary deflector on north side of roof with short piece of gutter. (David Milne?)
- Need gutter on S side above OBP prep area.
- Spread gravel on roadway between museum and airstrip (PWS front-end loader to transport gravel?).
- Install aeroplane propeller display in museum, and label.
- Organise and install a more imaginative donation box.
- Paint angle-brackets under exterior display ledges with epoxy brown.
- Install Freddy's fringe.
- Tidy wall (old door) under Charlie panel (perhaps cover old door with a display or branded tin-bags).
- Replace cardboard tin returns with new ones printed on paper.
- Create extra information folders.
- Stools for the museum - encourage Par Avion to contribute.

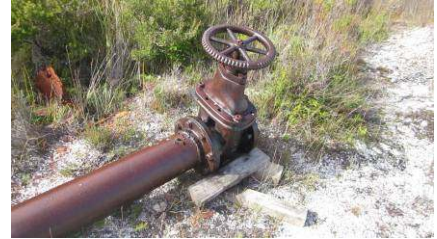
Well-oiled gate-valve, a potential exhibit on the future mining trail.  
Photo: Janet Fenton

The annual fish-oiling program (see Appendix 1) as recommended by Heritage Tasmania, was continued, thanks to Mel and David, who oiled many pieces of outdoor standing machinery and objects in the Smelter Shed. Options for stabilising the separating plant were discussed.

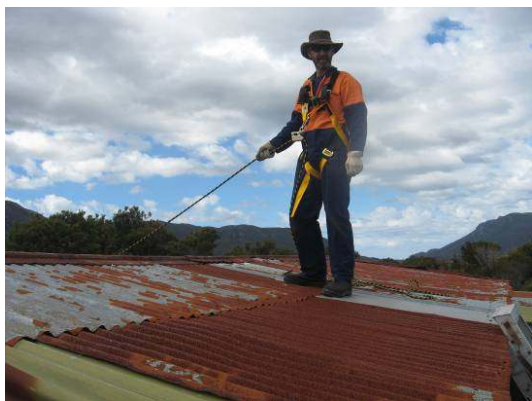
Leanne and Mel did an audit of sheets and colours of roofing iron at PWS works depot. At the Rallinga mine site, Chris re-roofed the dump truck shed using surplus second-hand brown Colorbond. The smelter shed roof was patched with surplus green iron but requires a complete re-roof to protect the heritage smelter and associated equipment. Rob and Leanne Banfield offered some green Colorbond that they have spare on their property. Thanks to Rob's timely organisational skills this was packed and loaded aboard *Ballbreaker* and freighted to Melaleuca on the PWS tractor-shed rebuilding trip in April. It is now on site ready for next year.

Chris Creese working on the smelter shed roof.  
Photo: David Butler

- **Works depot**  
Install a new sign "PWS Works Depot" as there has been considerable confusion.
- **Mine Sites**
  - Re-roof smelter (roofing iron is on site)

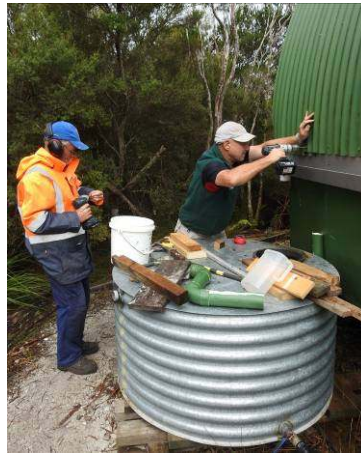
New stainless steel custom-made guttering was installed and plumbed-in on the Second bushwalkers' hut ('Launceston Walking Club' hut). The guttering style followed the pattern of that made in 2012 for the Charles King Memorial Hut, and was fabricated by Minehans in Kingston. This material was chosen for its longevity in a challenging climate. Installation was carried out by David Milne, Mark Simpson, Ian Marmion and Rob Benfield.

David and Mark installing new guttering, bushwalkers hut.  
Photo: Ian Marmion

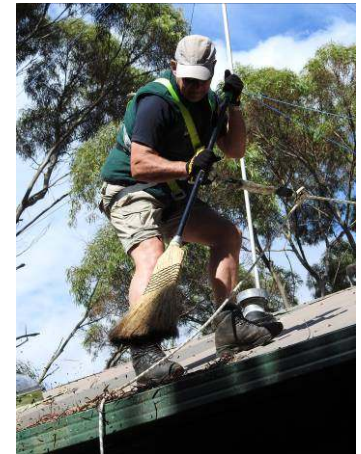
Routine gutter cleaning at PWS Quarters was done by Mark Simpson, David Milne and Ian Marmion. This is a difficult task because of the high roof, slope and damp condition. The gutters clog with leaves and a better solution for the job is necessary. Mark agreed to draw up a fixed installation for future securing of rope.

Mark cleaning the PWS Quarters roof and gutter.  
Photo: Ian Marmion

- **PWS Quarters gutter**  
Cleaning gutter is unsafe especially in damp conditions when the roof is slippery. A different gutter-guard arrangement would help. A deck all around the building would make it easy to access the windows and gutters from a step-ladder. Meanwhile design and install a permanent rope-attachment system fixed to that roof. (Mark Simpson)

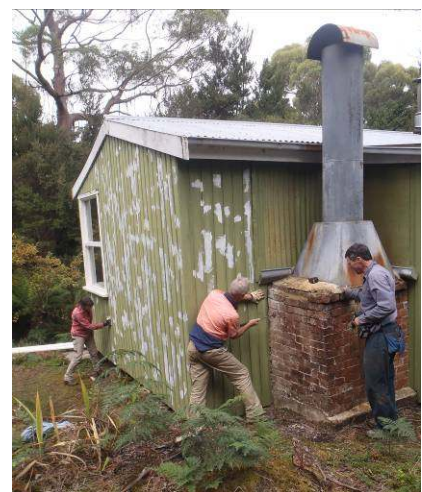
The historic Claytons homestead, where Win and Clyde Clayton lived from 1962-1976, was an integral part of this year's Friends of Melaleuca Working Bee. Following the major 2017 footings replacement program, a team of up to six volunteers led by Rob Banfield and transported by coxswain Dave Ross energetically completed a much-needed repair and repaint of most of the exterior. Work took three days (12 person days, 84 hours approx) to complete the following tasks:

Work at Claytons.  
Photo: Leanne Banfield

- Re-nailed, sanded, prepared vertical ship lap radiata pine cladding on northern and chimney walls and applied two top-coats of water-base Solagard olive green .

- Prepped and applied rust-seal to sheet metal cladding and metal chimney parts
- Primed and top-coated new cladding boards (4 unused are under the building).

- Replaced some rotten boards on southern wall; cleaned wall and applied one entire top-coat of Solagard.
- Prepared and spot primed and two coats of Solagard on east wall.

- Limited spot painting on west wall
- Short term painting maintenance done on two windows.
- Fitted vertical flashing at the corners of the building. (Walkers hut gutter re-used as flashing.)

- West wall and south wall bottom plate aluminum flashings fitted
- Removed two large ply panels that were seriously delaminated on inside north wall of loungeroom, sealed the backs of new plywood panels, cut to size, fitted sheets and refitted all interior fittings.

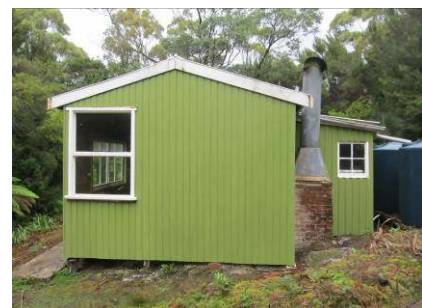
Newly painted wall!  
Photo: Janet Fenton

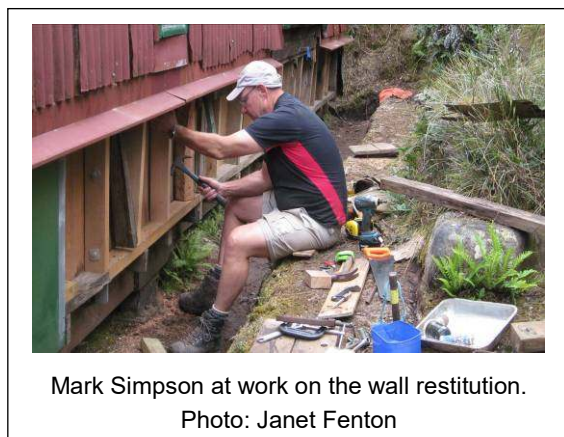
Geoff and Mark Simpson worked on the north side-wall at Kings. They removed cladding, jacked the walls straighter, installed extra studs and special structural brackets, and fixed new cladding, completing this phase of the house restitution project. Some treasures were found inside the wall cavity including a 1954 threepence and a plank stamped 'Edmonds Acto Baking Powder 6 doz, 14oz'.

Mark Simpson at work on the wall restitution.  
Photo: Janet Fenton
