# Wildcare Friends of Melaleuca Working-bee report, 2024

# Working bee, March 2024

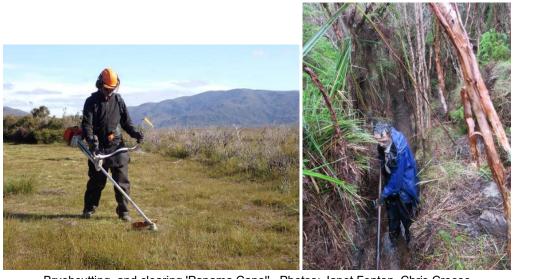
Brushcutting, and clearing 'Panama Canal'. Photos: Janet Fenton, Chris Creese

<u>Draining:</u> David, the drainer-in-chief, quietly set about clearing drains that needed attention. His main achievement this year was the large and very overgrown drain east of Willsons. The 'Panama Canal' emerged after a day of hard hacking through the jungle and soggy digging in the drain.

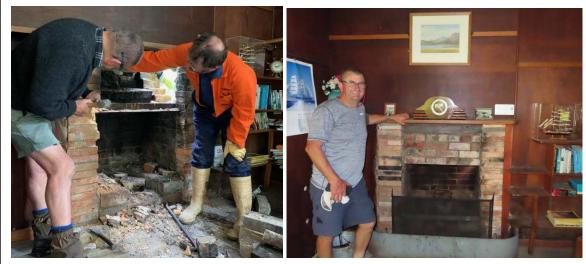
Mark and Chris working on the fireplace at Claytons.

Repairs to the fireplace and external chimney were a major job this year. Bricklayer Mark Devine and team took apart the unsound portions of the existing fireplace, removing loose bricks and corroded lintels. Replaced deteriorated bricks with like. The old rusted lintels had expanded,

causing problems, so these were replaced. For this work the heavy welded steel chimney was temporarily raised off the fireplace. Chris made up stainless flashings to properly drain rainwater away from the valleys between the house-walls and the base of the chimney, the past cause of the fireplace's problems. Fitting was an awkward job. Andrew saved the situation by ordering, via Barbara's internet, a right-angle drill attachment which miraculously arrived the next day via Par Avion! Thanks Boon brothers.

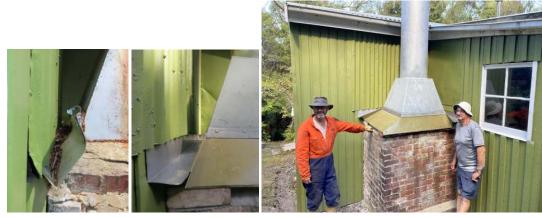
Chimney at Claytons: before, during and finished. Photos: Geoff Fenton, Chris Creese, Andrew Boon
